VIGILANTE FORENSIC

Report of: William J. Vigilante, Jr., PhD, CPE

Date: July 31, 2018

Case Caption: Pamela Brackin
Vs.
Medtronic, Inc., et al.

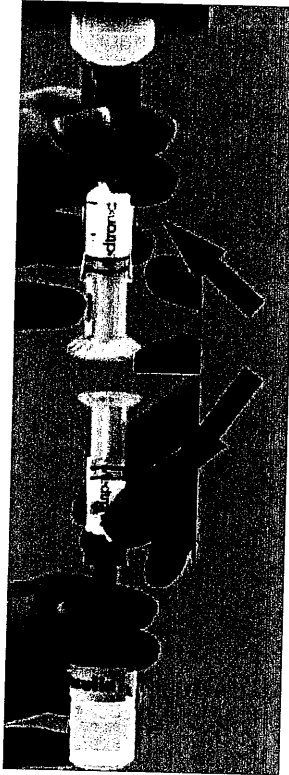
The instructions should have conspicuously and explicitly instructed the user on the proper orientation and position of the reservoir when removing it from the transfer guard (1-3,5, 8-11). The warning should have alerted the user to the potential hazard associated with any liquid contaminating the P-cap connector, the need to ensure the top of the reservoir and P-cap connector were dry before connecting them, to dispose of the infusion set if liquid got on the P-cap connector, and the consequences of failing to properly complete the steps (i.e., over or under infusion of insulin). For example, Medtronic and Unomedical should have ensured the Getting Started guide highlighted the need to flip the unit over and ensure the reservoir was above the insulin vial before removing it from the transfer guide. An intervening pictograph (e.g., 8a) of the “To Fill the Reservoir” instructions should have been provided showing the reservoir-transfer guard-insulin vial being inverted as depicted in Figure 1. The pictograph should have included conspicuous arrows to indicate and emphasis that the reservoir was flipped over. For example, Amichai Vardi, Medtronic’s prior director of quality, testified that an arrow is used to emphasize the flipping of the unit (AmV, 45,46,268).

Figure 1. Pictograph for step 6a.

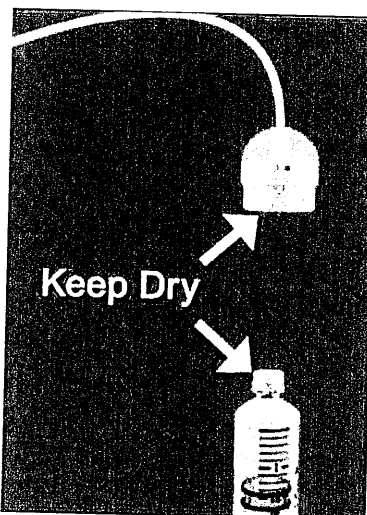
In addition, step 1 of the “To Connect the Tubing” instructions should have been expanded to include a 1a: check top of reservoir before connecting to P-cap. Step 1a should have included a pictograph such as depicted in Figure 2.

Figure 2. Pictograph for step 7a.

A warning should have accompanied step 1a of the “To Connect the Tubing” instructions which stated (11):
